Saugeen Shores Beach Maintenance Plan

Town of Saugeen Shores Beach Maintenance Plan

February 2021 Version

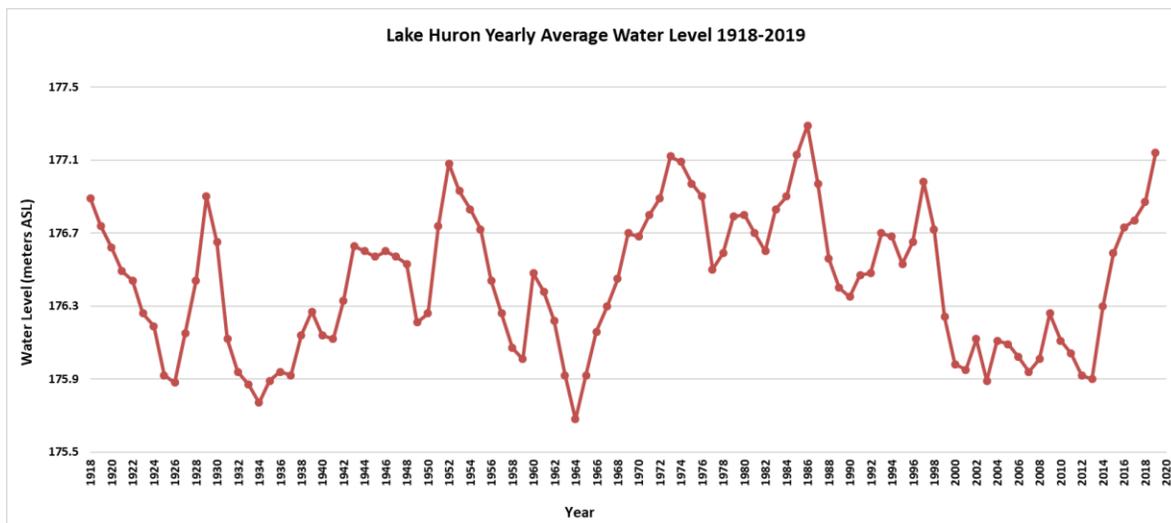
Figure 1: Hydrograph showing historical water levels on Lake Huron 1918-2019.

Citizens hold nostalgic views of wide sandy beaches without vegetation. Water levels are the most significant factor that change the waterfront experience. Figure 1 shows how the Lake Huron water level has change over the last 100 years. During the 1960s, levels were the lowest on record, but only for a short duration. At that time, there were wide beaches, but the vegetation had not had a chance to appear before high water returned. High levels ensued for the next three decades peaking in 1986, so wave impacts kept the vegetation at bay. From the mid 1990's onward to 2013, below average lake levels have resulted in wide beaches providing the opportunity for coastal vegetation to expand. The concern for many users of the waterfront is that the vegetation will grow to the water's edge eliminating the beach entirely. After 2013 and into 2019 water levels began to rise rapidly reducing beach width and disturbing shoreline vegetation resulting in significant change once again on the beach. The wave action will always maintain a beach of varying width depending on how much ice and storm activity have occurred during the off season. In order to accommodate all users of the waterfront, the Municipality will have to play a role to ensure that beach space is optimized.

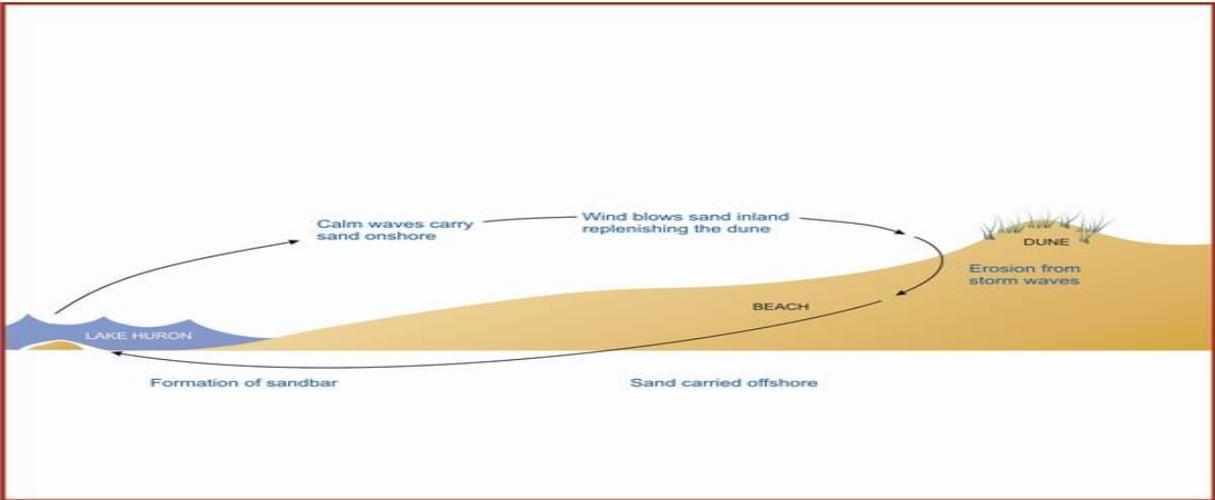
Figure 2 showing the “Sand Cycle”. Windblown sand collects forming a dune, waves (especially in storms and high water levels) will erode the dune carrying the sand lakeward to form sand bars which protects the beach. Gentle waves gradually move sand onshore to be carried by wind back to the dunes.

Sand is continually being eroded and deposited on the shore by waves. Storm waves will erode the beach, taking the sand offshore, and forming a sand bar. The sand bar acts as a temporary protective berm, absorbing wave energy that would otherwise reach the shore causing even more erosion. Once the storm subsides, gentle waves will gradually bring the sand from the sand bar back to the shore and re-deposit it on the beach. Once onshore, the sand is then prone to movement by wind.

Dunes form when sand is carried by the wind from the beach towards the land. Sand particles begin to move when wind velocity reaches about 20 kph. The smallest particles (0.05-0.15 mms. in diameter) are so tiny that they float in the air: this is known as **suspension**. Slightly larger particles (0.15 -0.25 mms. In diameter) move in a hopping motion known as **saltation**. The energy of the falling grains may not be completely absorbed on impact and may therefore rebound. This may cause another particle to jump or may push a larger grain (0.25 -2 mms. in diameter) forward. These larger grains are continually bombarded by saltation and being pushed forward: this is known as **sand creep**. Although most sand particles are moved by saltation, surface creep may account for 20-25% of the moved sand (Bagnold, 1954). Most of the sand is carried within 0.15 m (6 inches) of the ground surface. The very fine sands light enough to be carried by suspension are usually carried well outside of the active dune system.

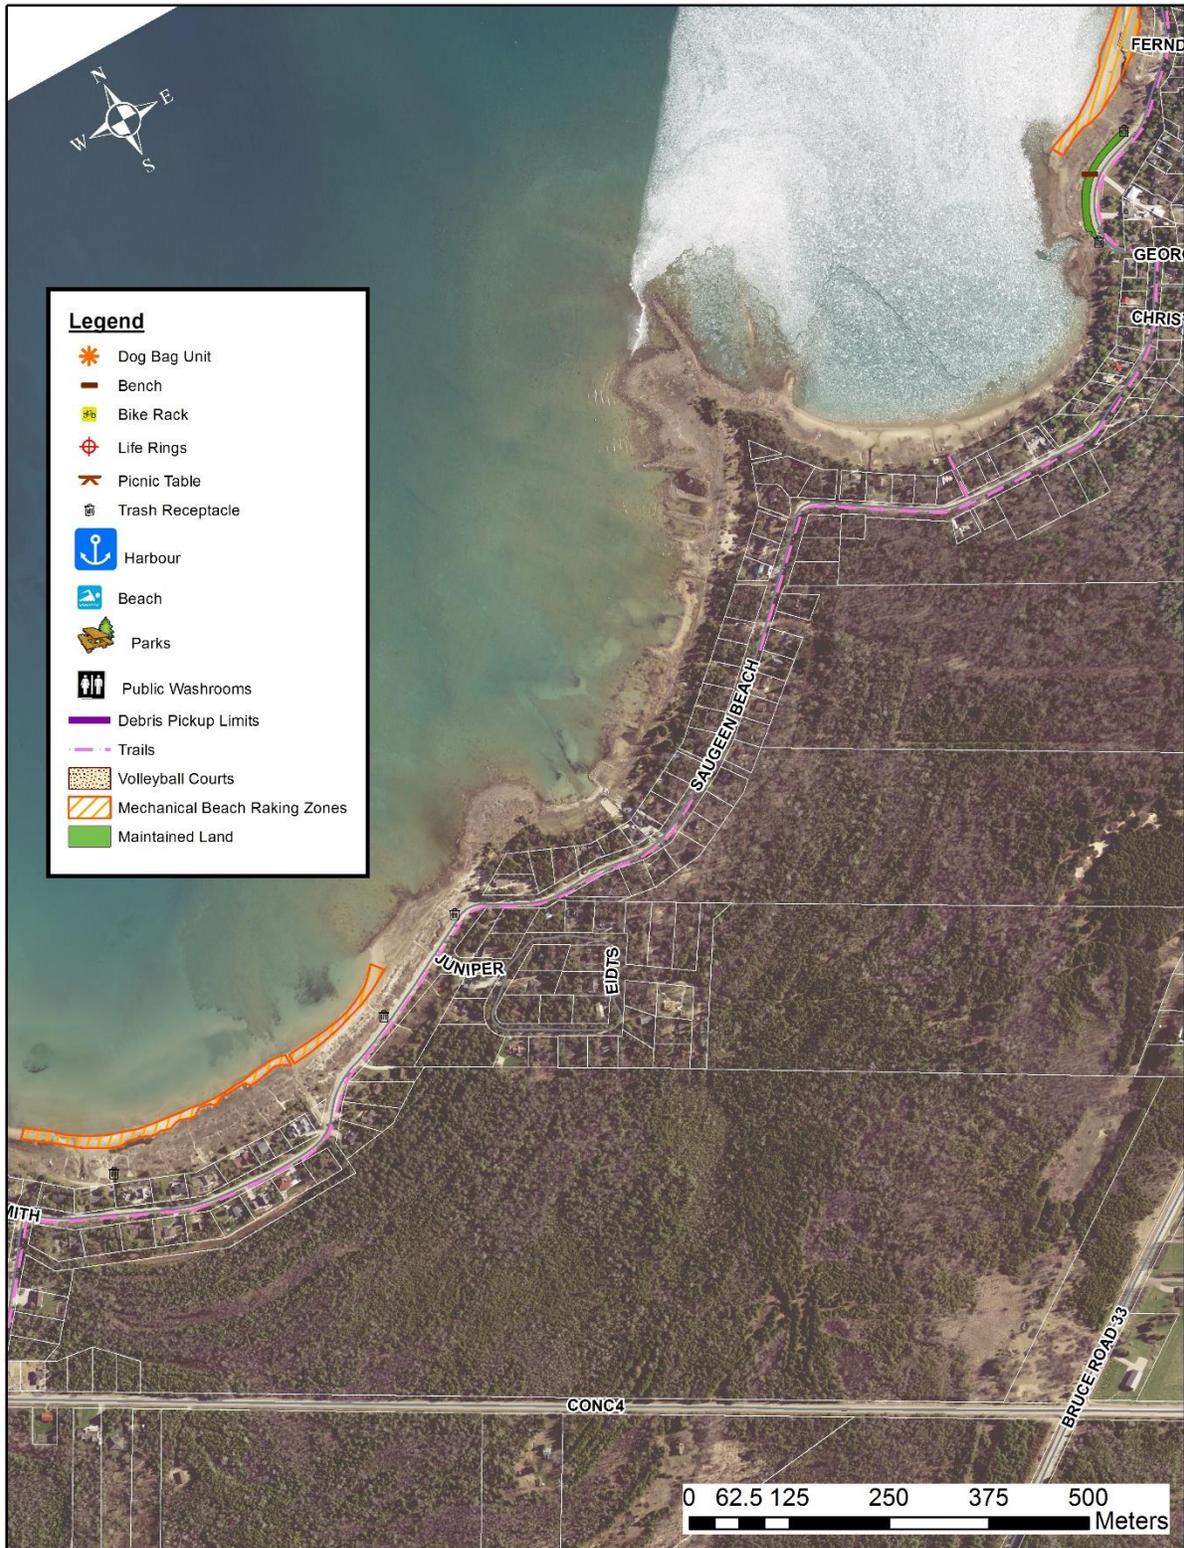
Maintenance Zone 1 – Saugeen Beach

Maintenance Zone 1 begins at Smith Lane and follows the waterfront to George Street. This particular area is comprised of a number of different elements from rocky points to shallow sandy beaches. Grasses and wetlands jolt the landscape along beach entry points in the middle portions.

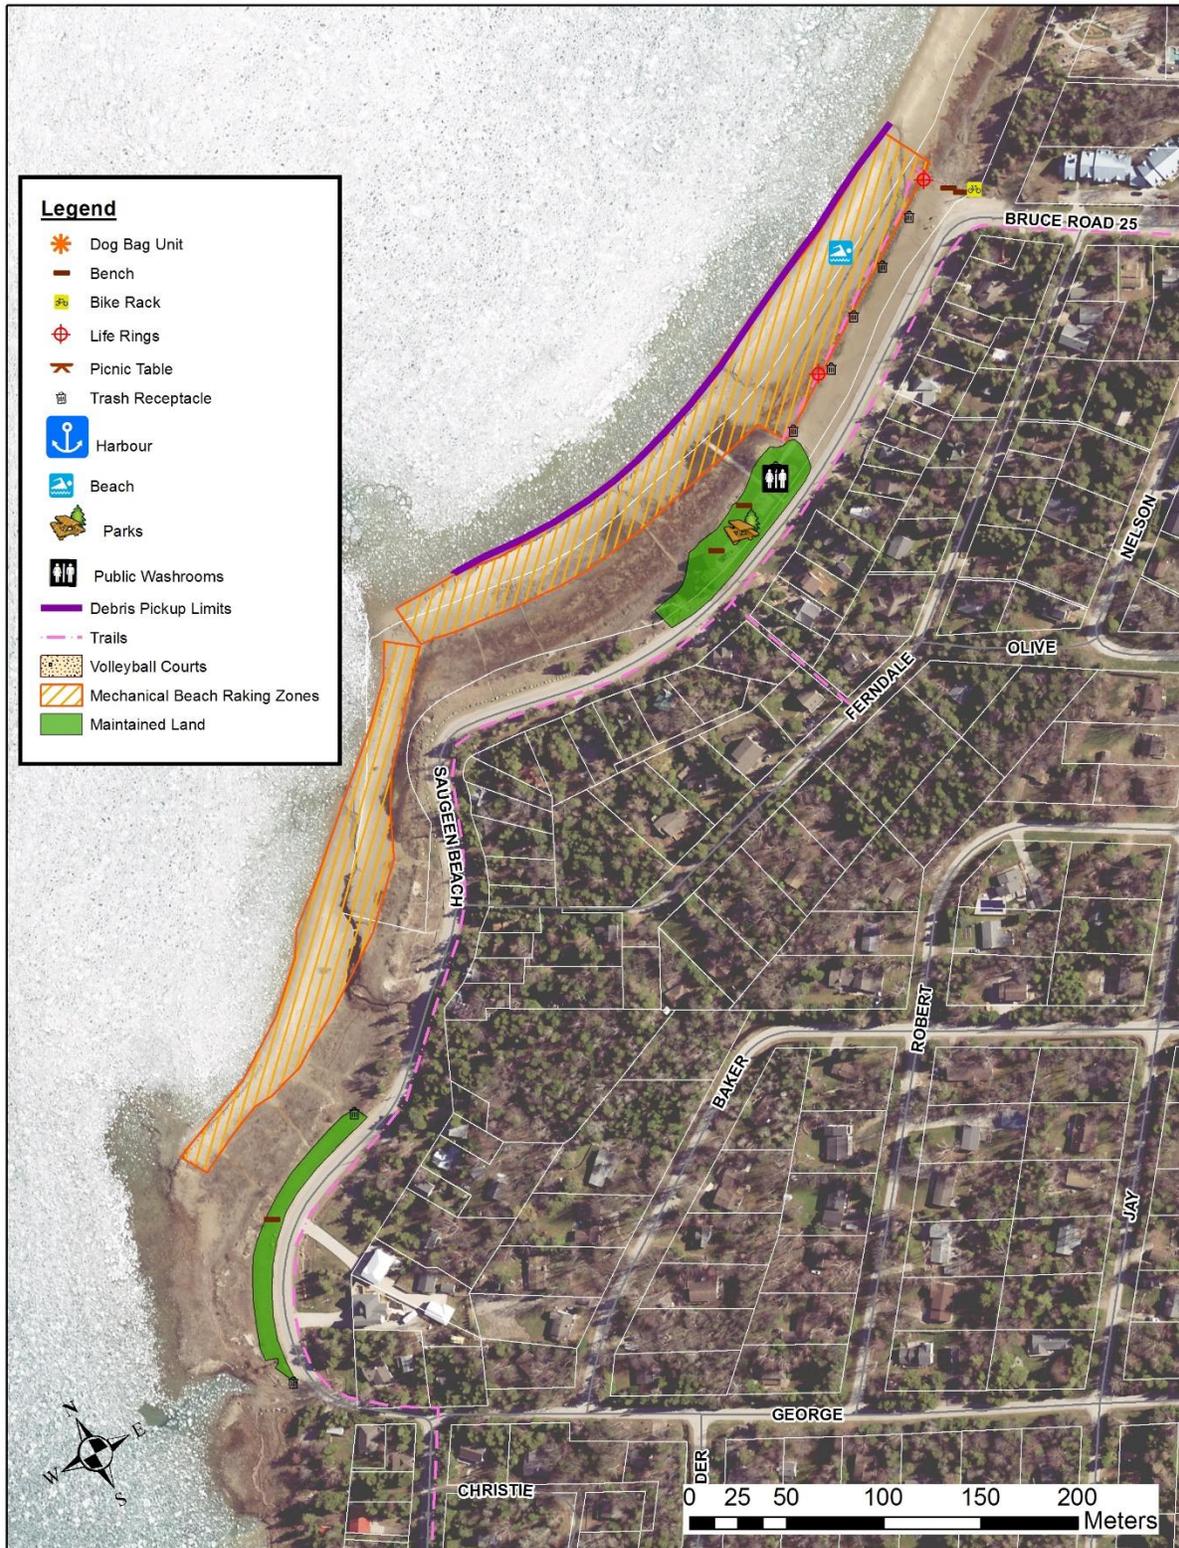
Maintenance Zone 2 – Gobles Grove

Maintenance Zone 2 begins at George Street with a natural shallow water area with non-maintained access ramp and concludes at Bruce Road #25. Gobles Grove is a well-used beach by residents and cottagers within the area, and also as a major destination for day users.

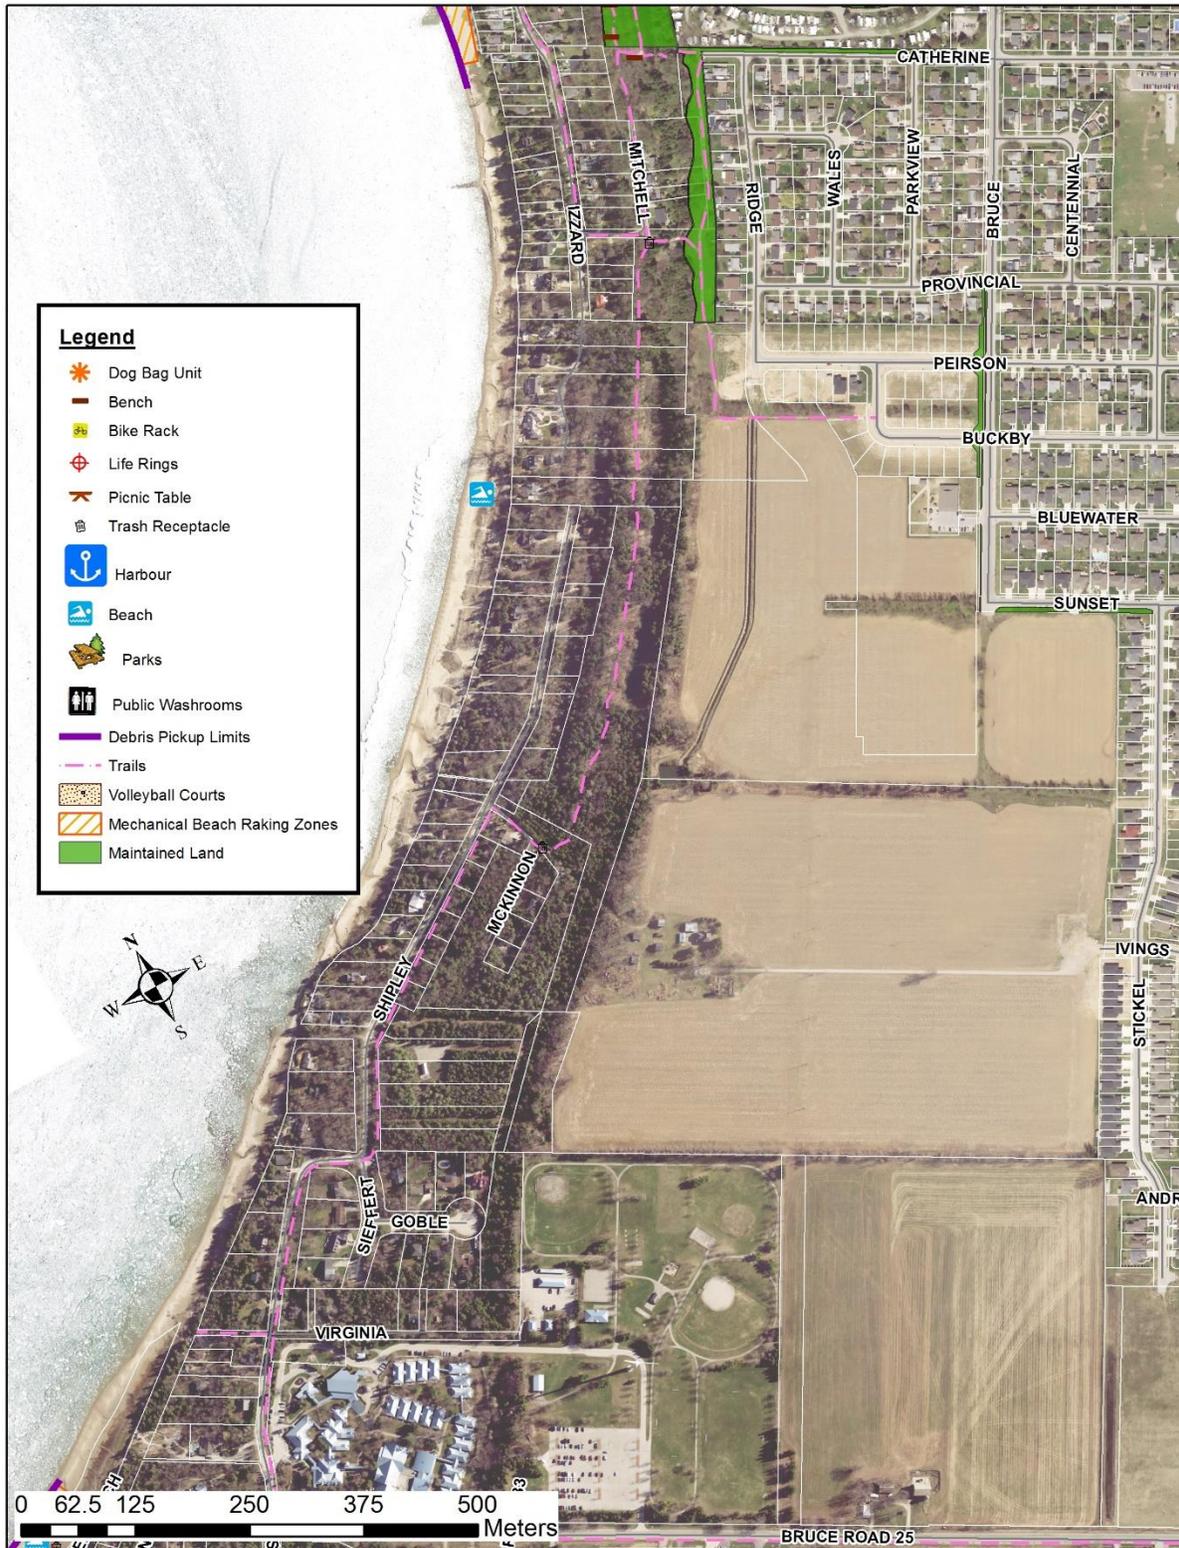
Maintenance Zone 3 – The Sands of Shipley

Maintenance Zone 3 historically had limited maintenance. Cottages abut to the high water level mark and some residents prefer the 'less is more' attitude along this piece of shoreline. Dunes have started to form during the low water duration and vegetation has started to grow closer to the water's edge.

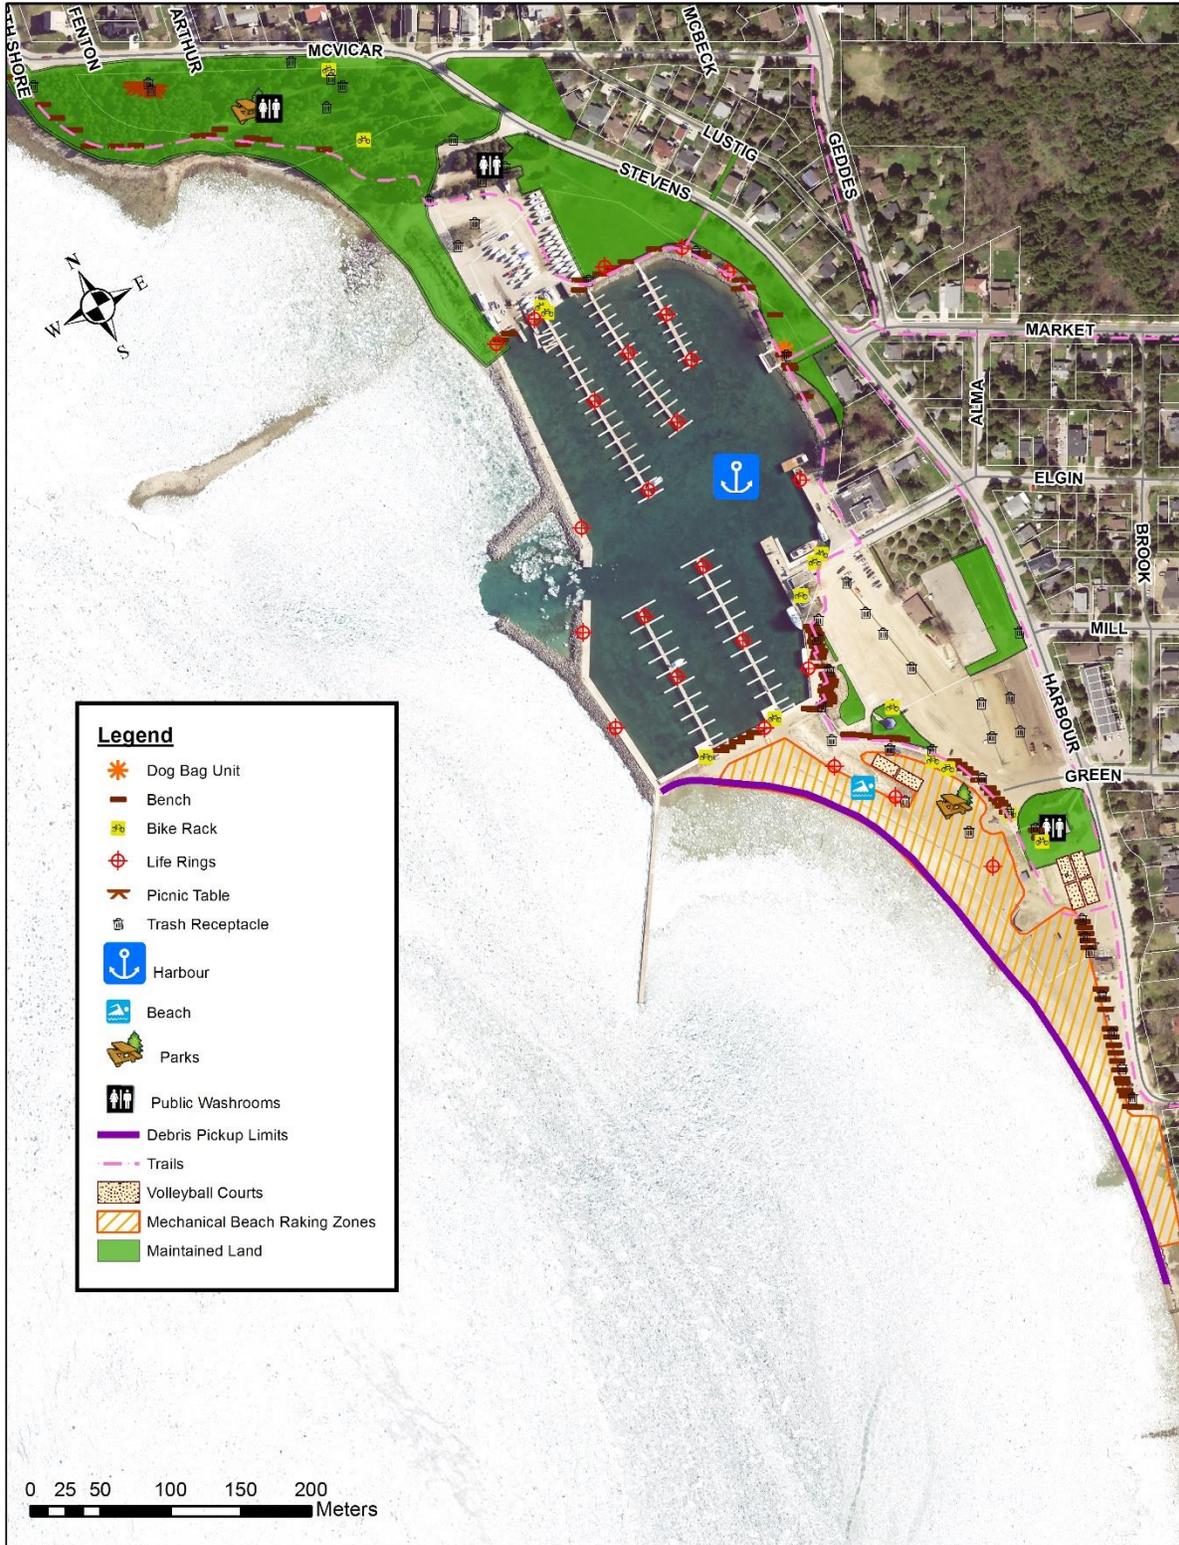
Maintenance Zone 4 – Port Elgin Main Beach

Maintenance Zone 4 destination commences south of the Izzard Road lookout at 538 Izzard Road and encompasses the beach northward to and including the North Shore Park. Considered to be the busiest of all the beaches in Saugeen Shores, it is a major tourism attraction. The soft sands and shallow waters are appealing for families, and the restaurant amenities provide eating establishments.

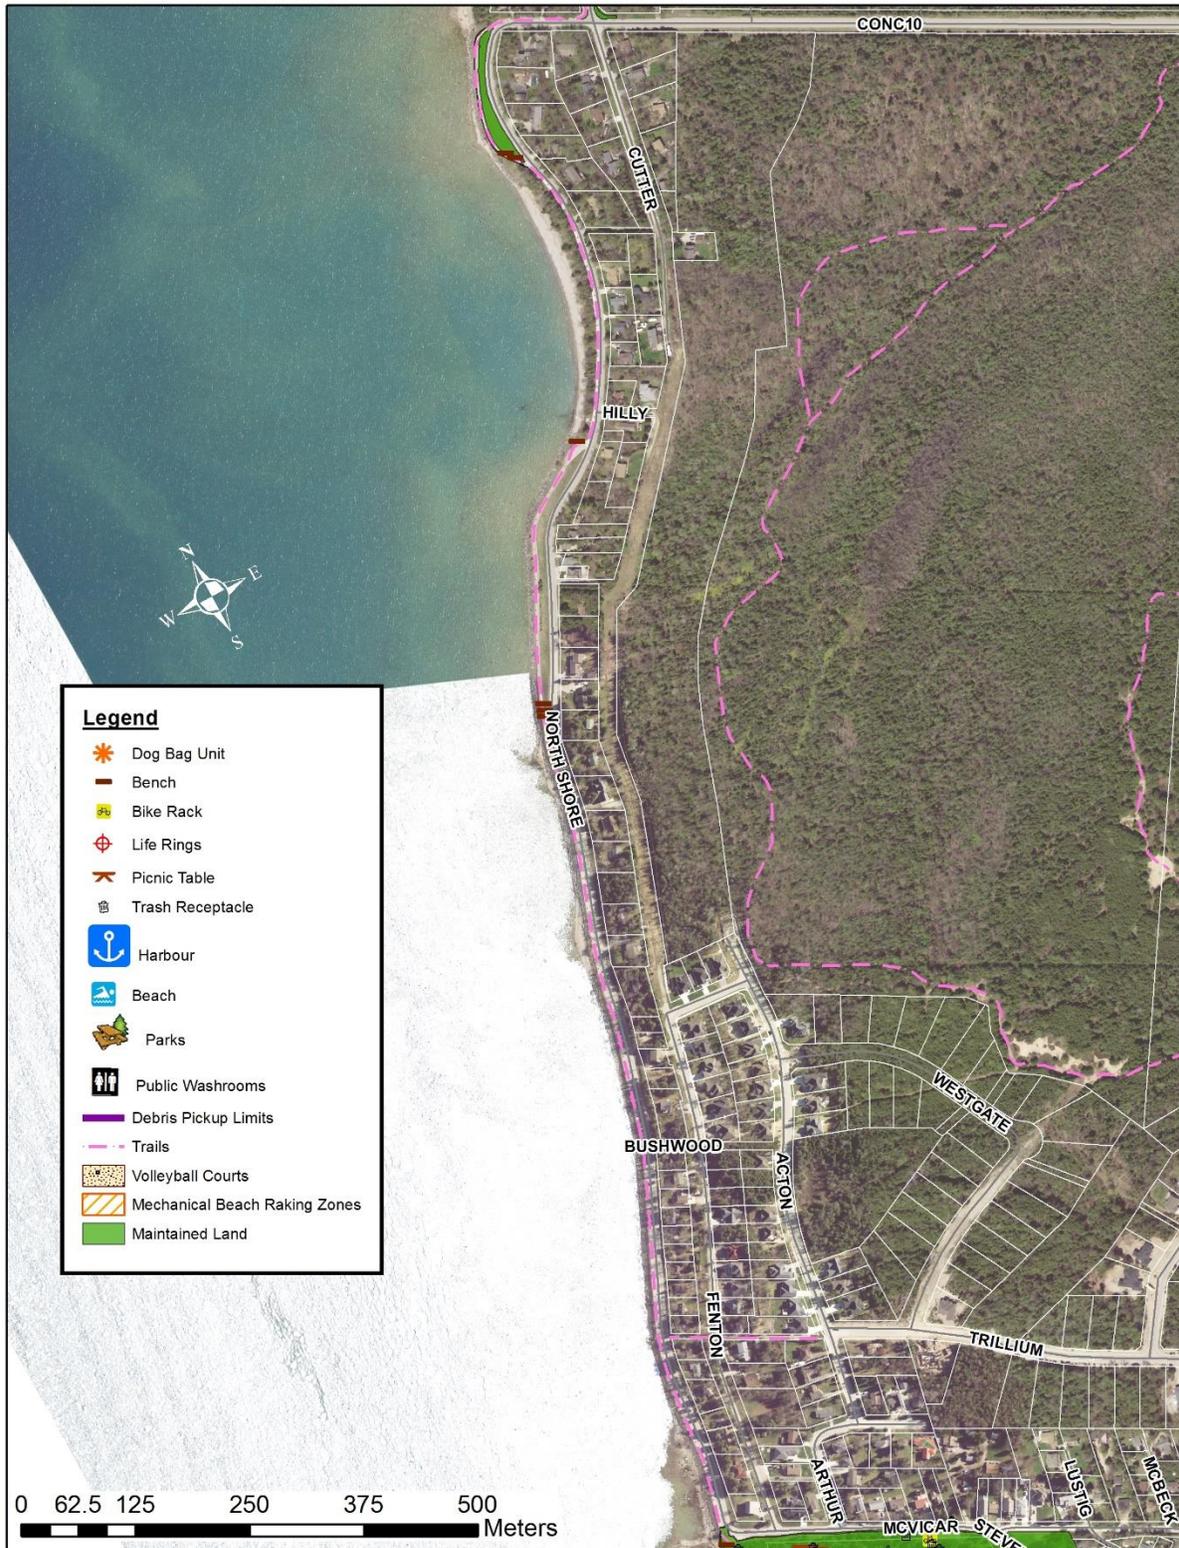
Maintenance Zone 5 – North Shore Trails

Maintenance Zone 5 starts at the north end of North Shore Park and continues to 10th Concession. Predominately shallow water, rocky points and outcrops. This portion of the waterfront is more enjoyed by those utilizing the North Shore Trail.

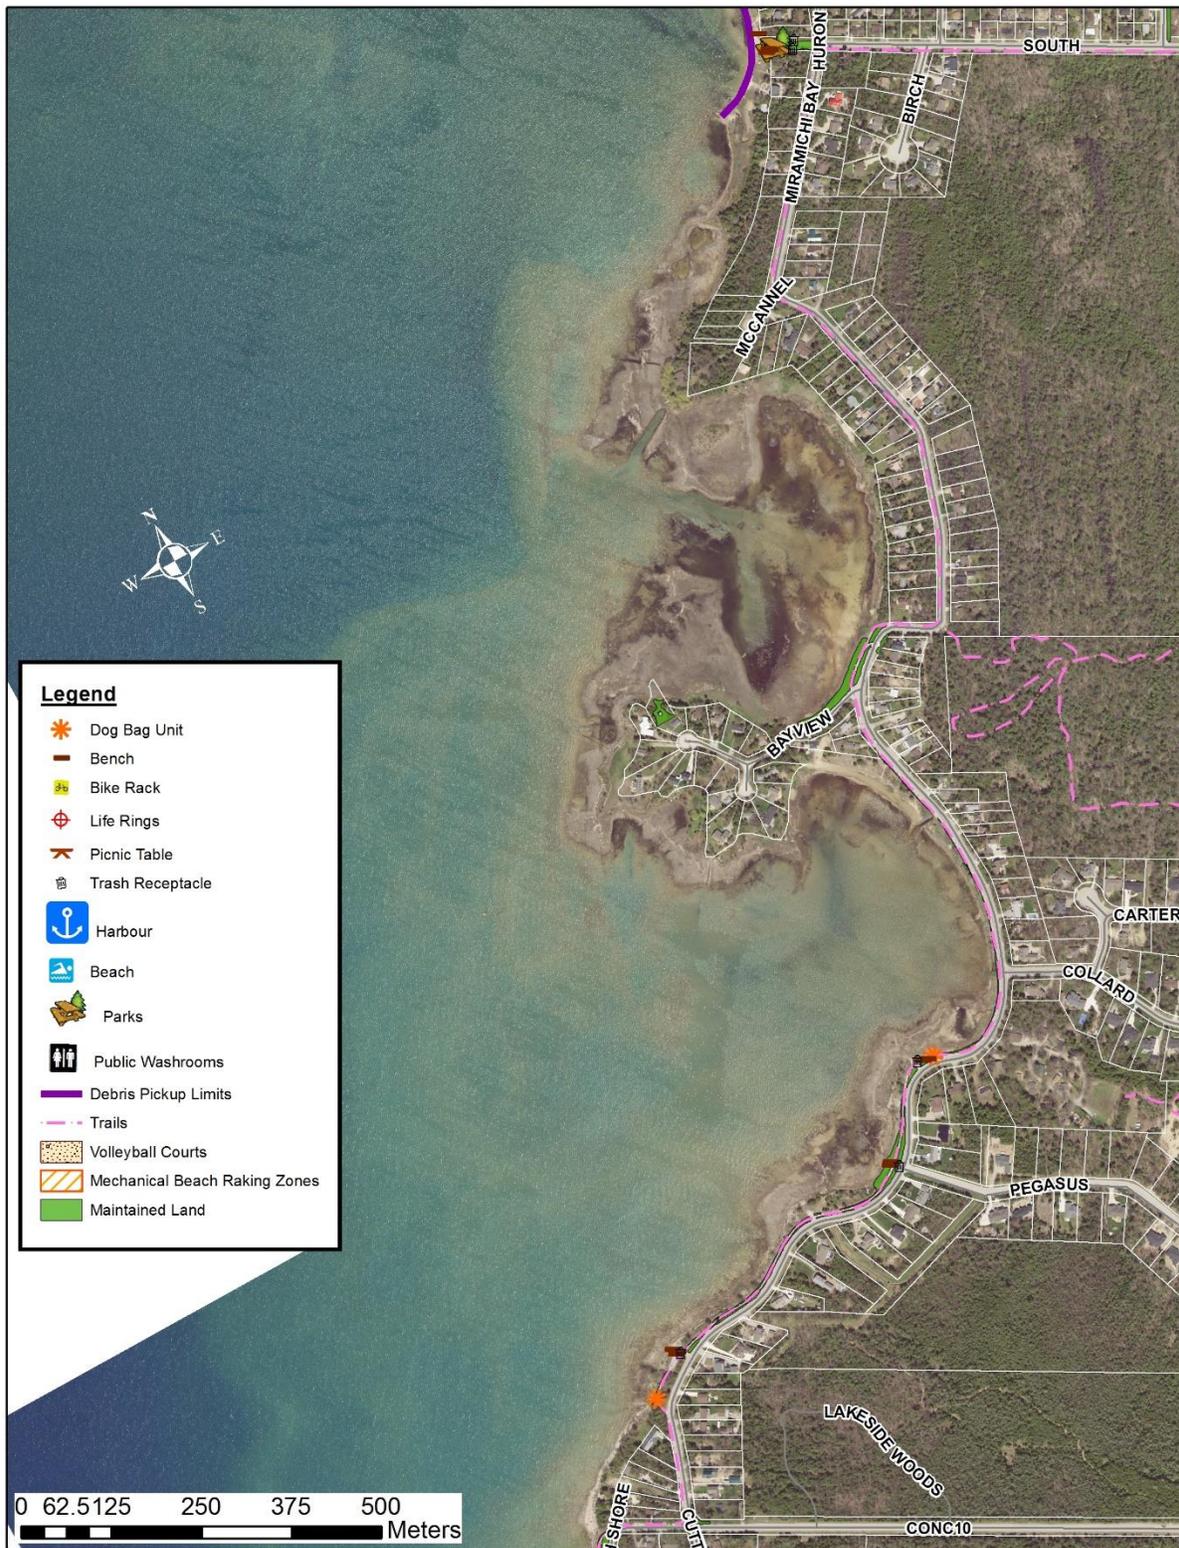
Maintenance Zone 6 – The Bays of Horseshoe and Miramichi

Maintenance Zone 6 is influenced by fluctuating water levels that greatly change the usage and dynamics of these two areas. Bird enthusiasts enjoy the wildlife that can easily be seen in the bays, and the lookout areas accommodate those individuals looking for a short retreat. The recent rise in the water levels has brought boating activity back into both Miramichi and Horseshoe Bay. This destination starts at the 10th Concession and concludes at South Street Beach.

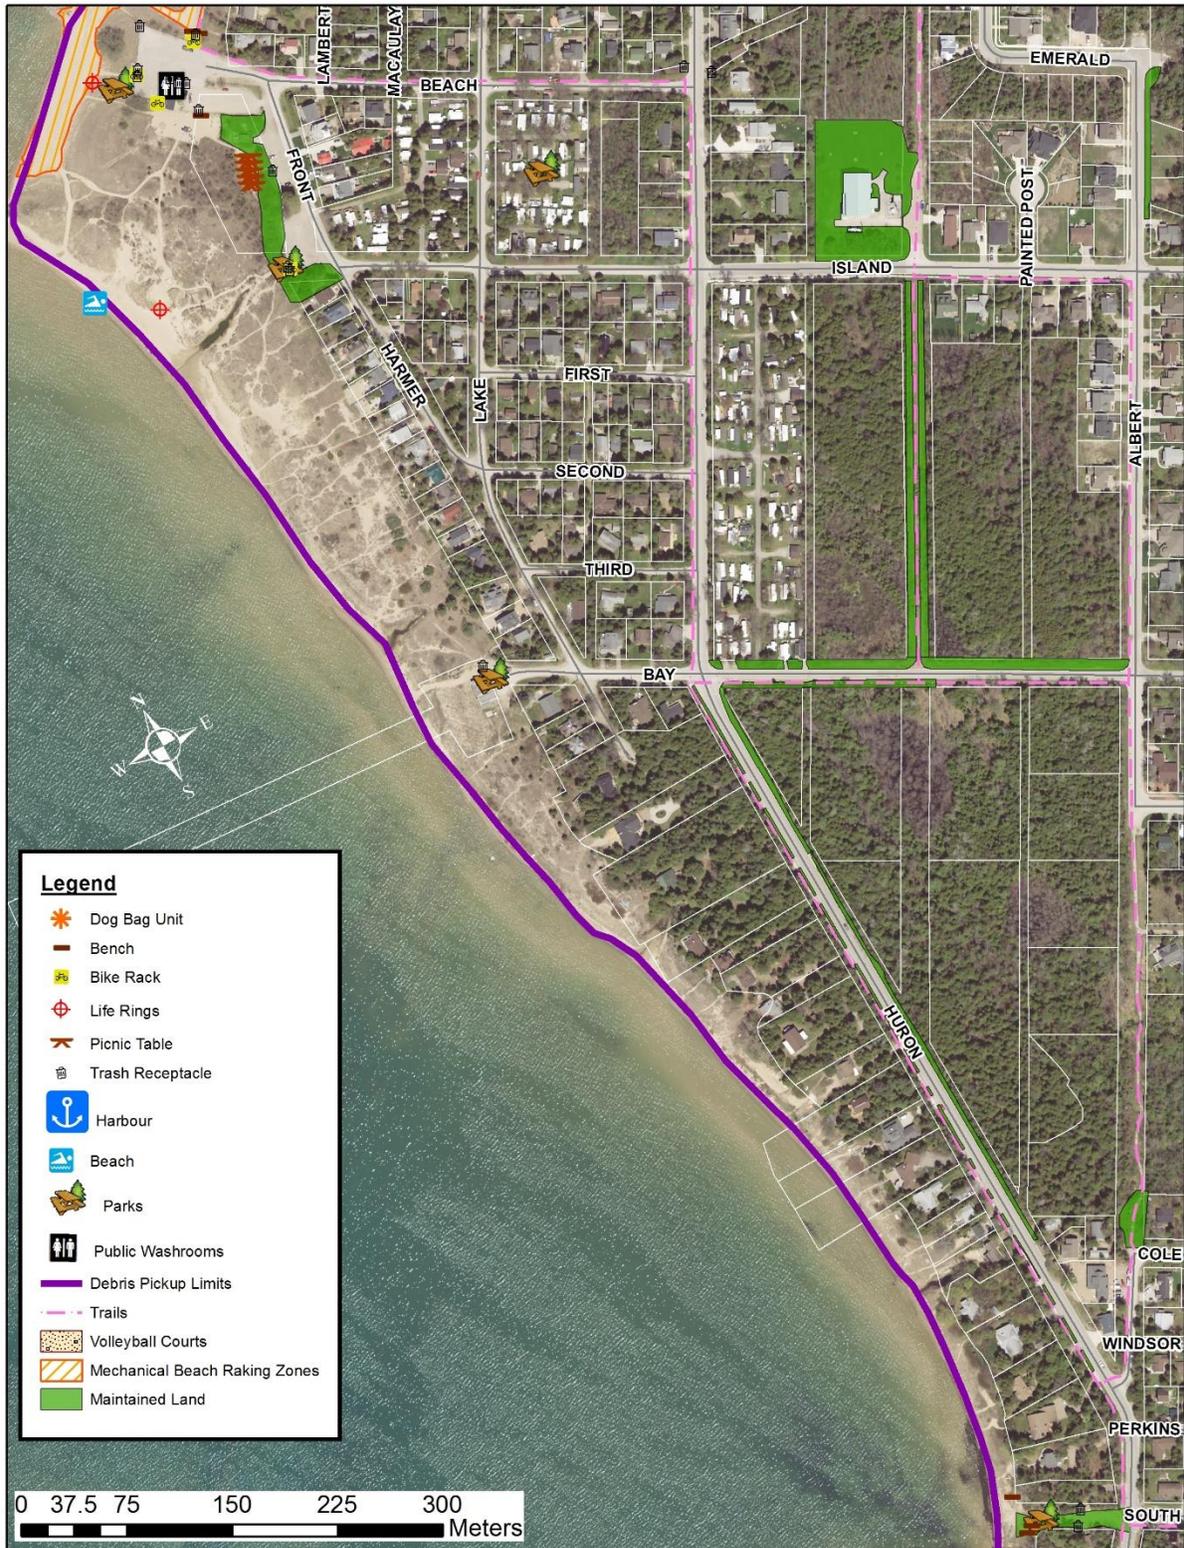
Maintenance Zone 7 – South Street to Beach Road

Maintenance Zone 7 starts at South Street and Beach northward to Beach Road adjacent Gerry's Fries, these beaches are small in comparison to other Southampton Beaches, however their soft sand and shallow waters are an attraction to many users.

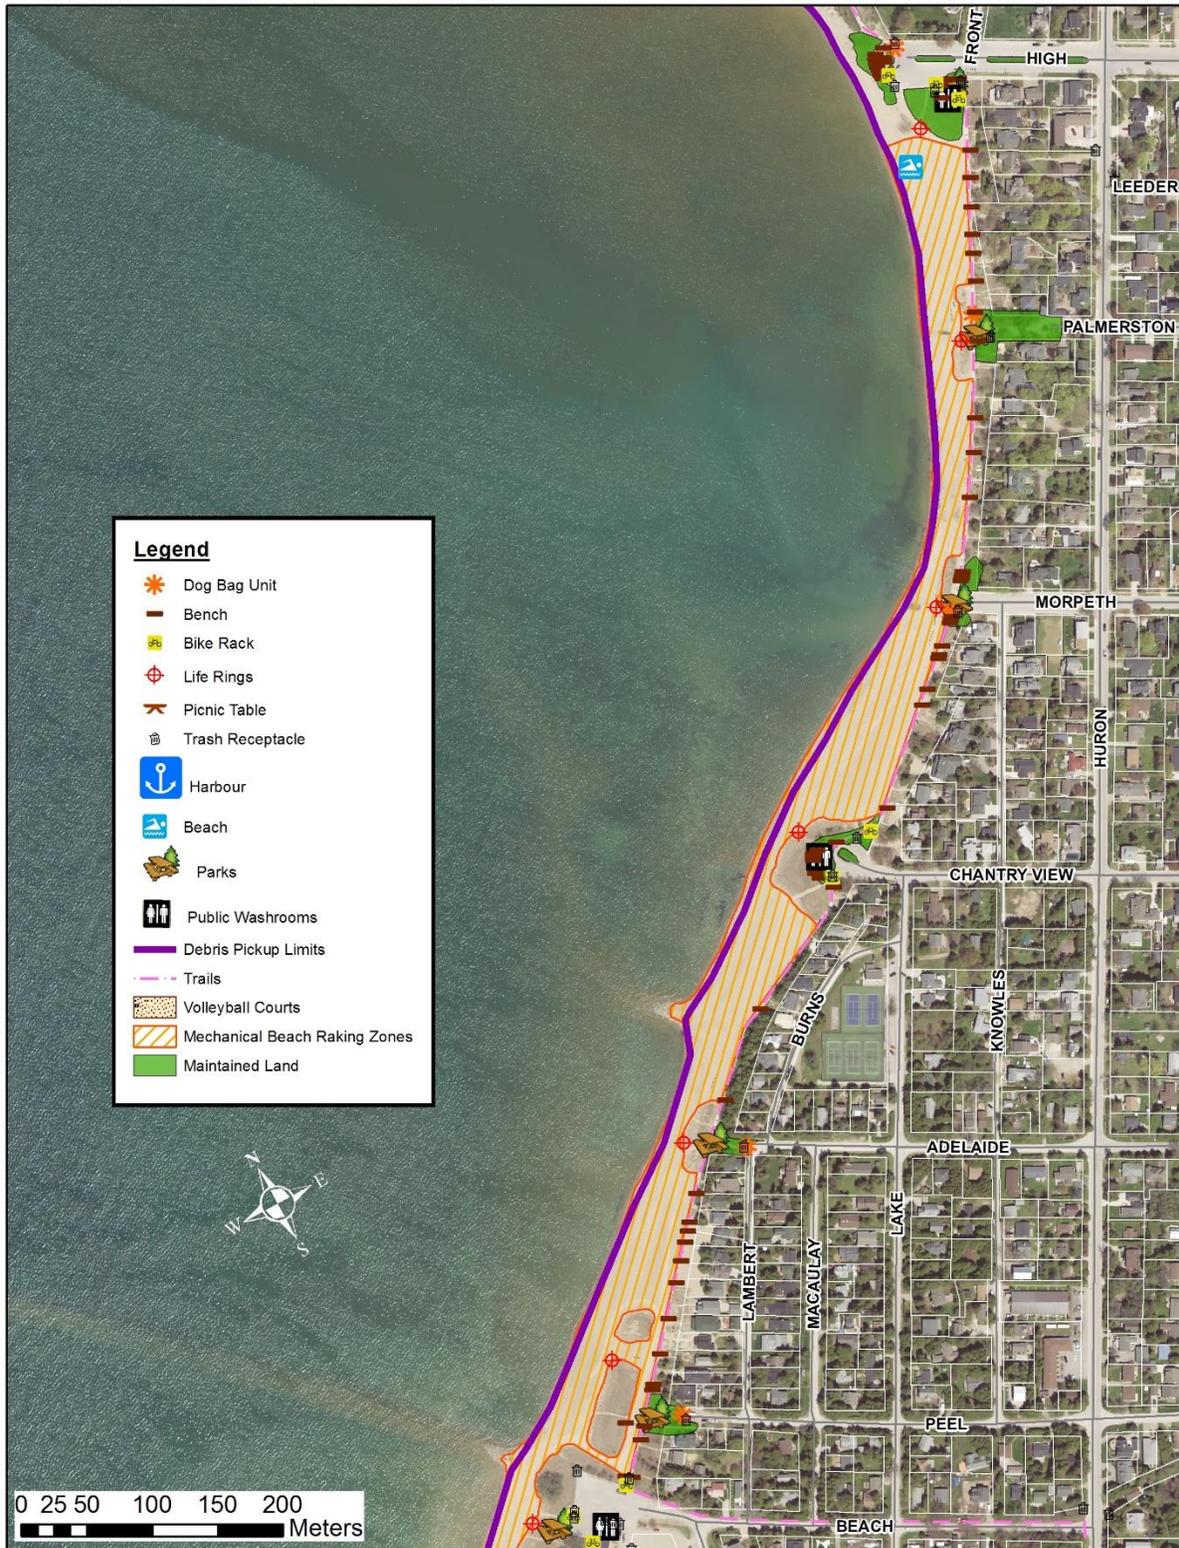
Maintenance Zone 8 – Beach Road to High Street

Maintenance Zone 8 area of waterfront is a draw for many users in Southampton. Its close proximity to the downtown makes it a desirable destination. Its accessible beach access points are an attraction for those wishing to walk the sidewalk to watch the sunset or to sit on the many benches.

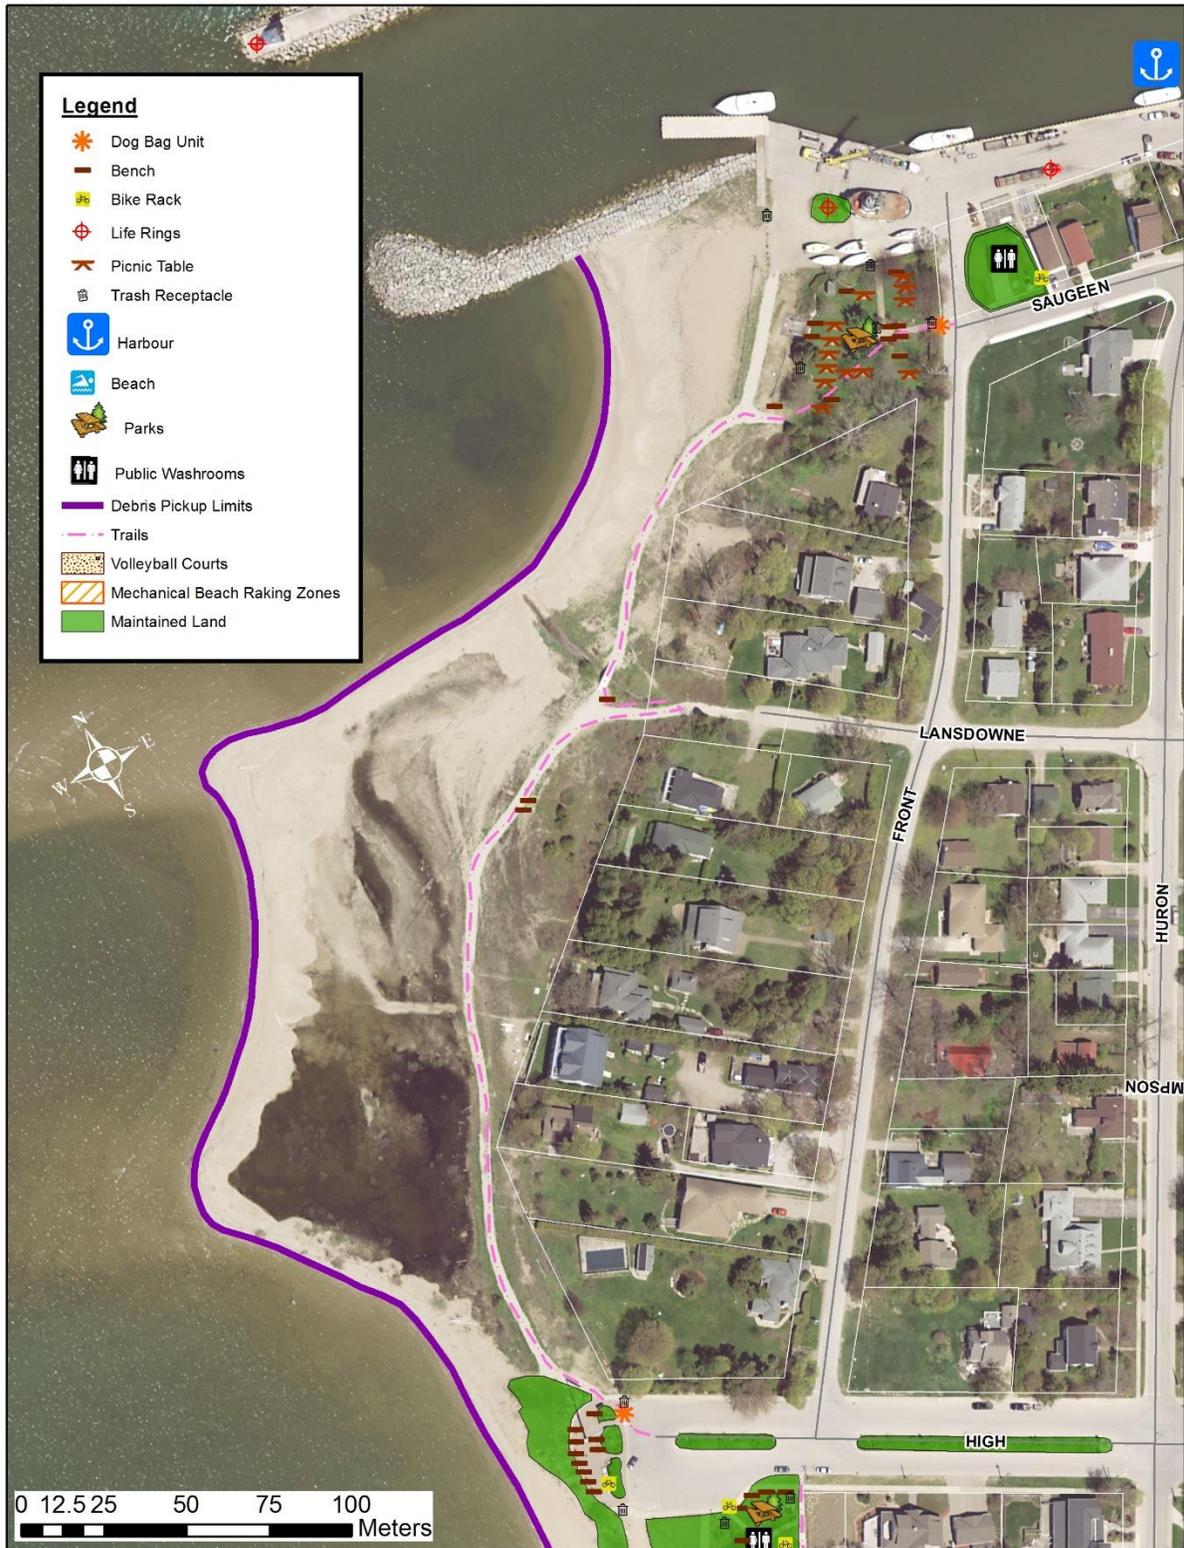
Maintenance Zone 9 – High Street to Saugeen River

Maintenance Zone 9 area comprises the area north of the flag in Southampton. The landscape changes considerably in this portion from a sand beach to a pebble beach with walking trails. This natural portion of the beach is enjoyed by many seeking a relaxing alternative to a sandy busy beach. A new pathway has assisted in opening up a portion of the waterfront to additional usage, and now boasts the first butterfly gardens within the area. In 2019 and 2020 high water radically changed this section and the gravel berm, pond area and the southern section of the Captain Spence Path has been completely consumed by Lake Huron raising water levels.

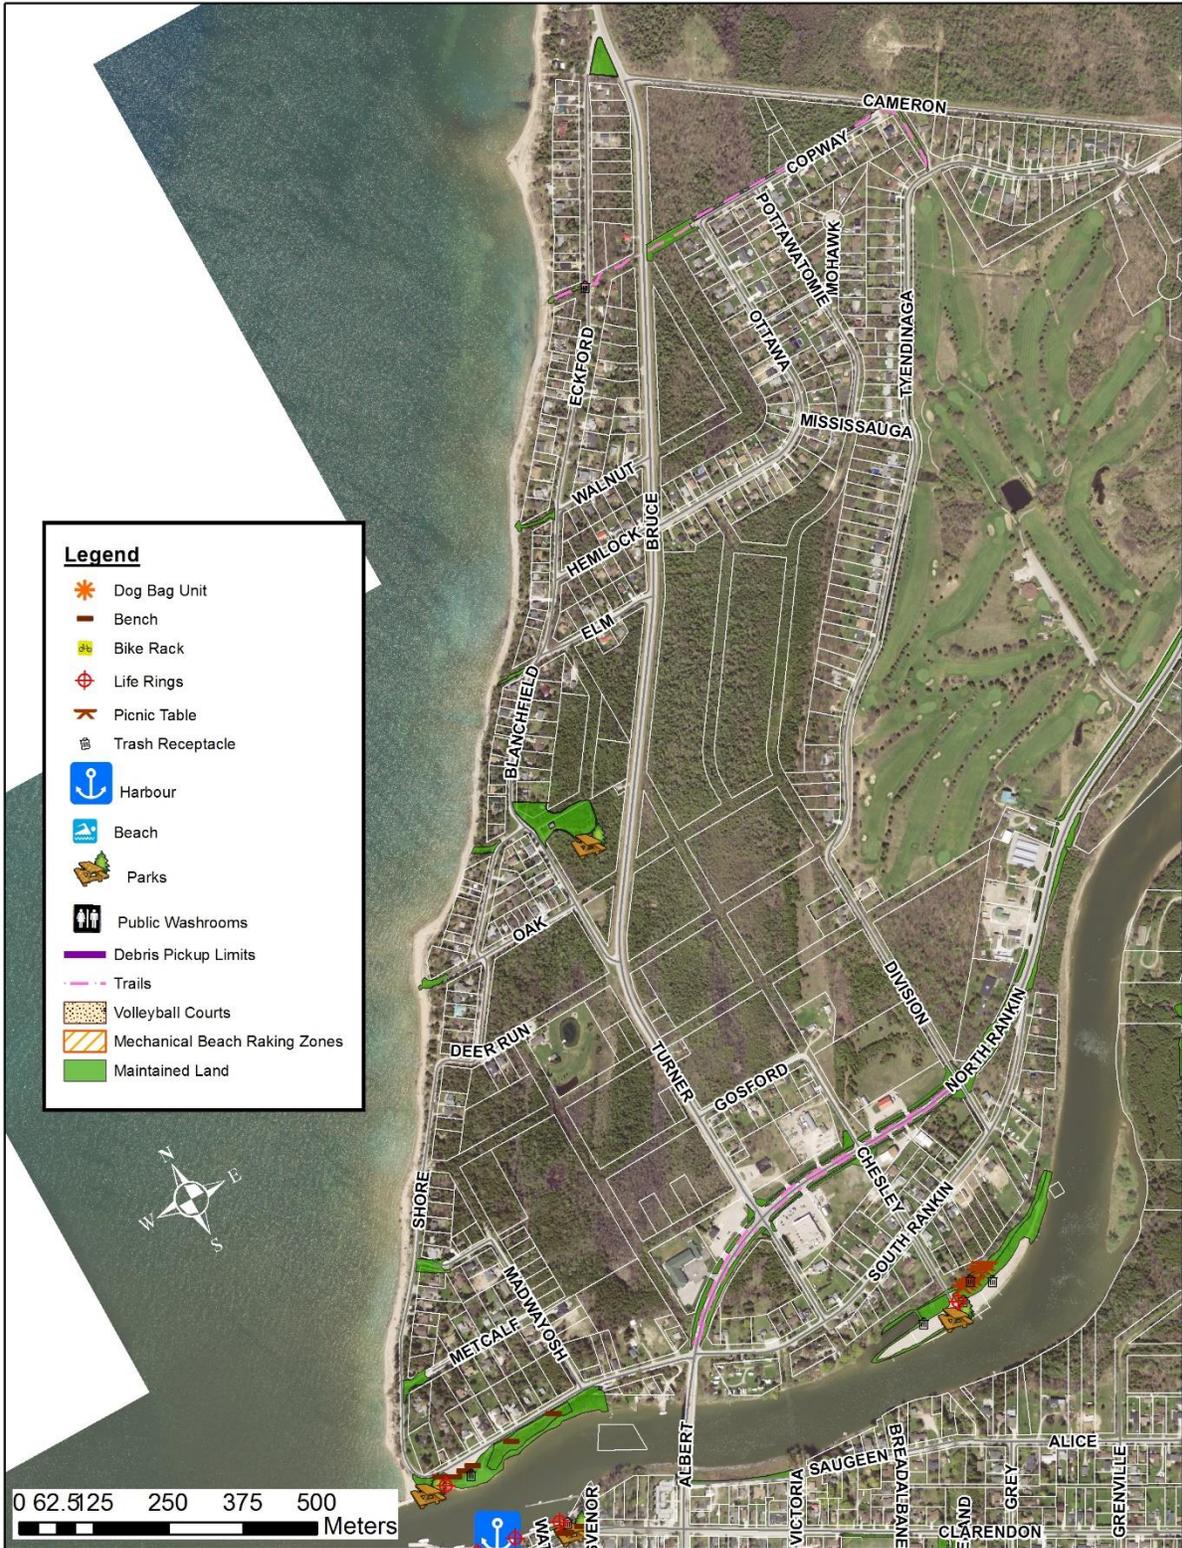
Maintenance Zone 10 – Scubby’s Point and the Northern Sands

Maintenance Zone 10 includes the River mouth that is a popular destination for individuals who fish. It is an ideal location for watching the sunset on a warm summer's day. Further north, there is a mixture of rocky beach entrances as well as small patches of sand beaches.
